TESTS SHOW CROSSLINKED ROTOMOLDED POLYETHYLENE TANKS HIGHLY RESISTANT TO RUPTURING

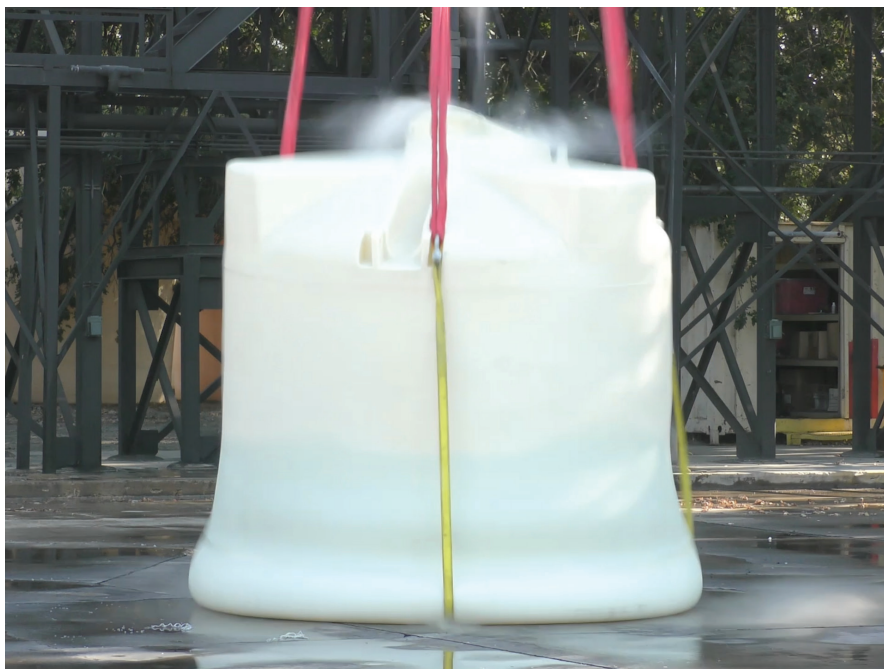
The crosslinked polyethylene tank did not fail or develop any cracks, during the 5 metre drop test.

The linear tank failed catastrophically. The associated crack propagation appeared to be consistent with the un-zipping characteristic found in linear polyethylene resin grades. The crosslinked polyethylene tank did not fail or develop any cracks.

The same crosslinked polyethylene tank was then refilled with 5,000 kg of water. That's over 15 times its weight when empty. It was then dropped from the same height, again with no damage. The tank still containing 5,000 kg of water was dropped a third time, but from 15 m. There was no damage.

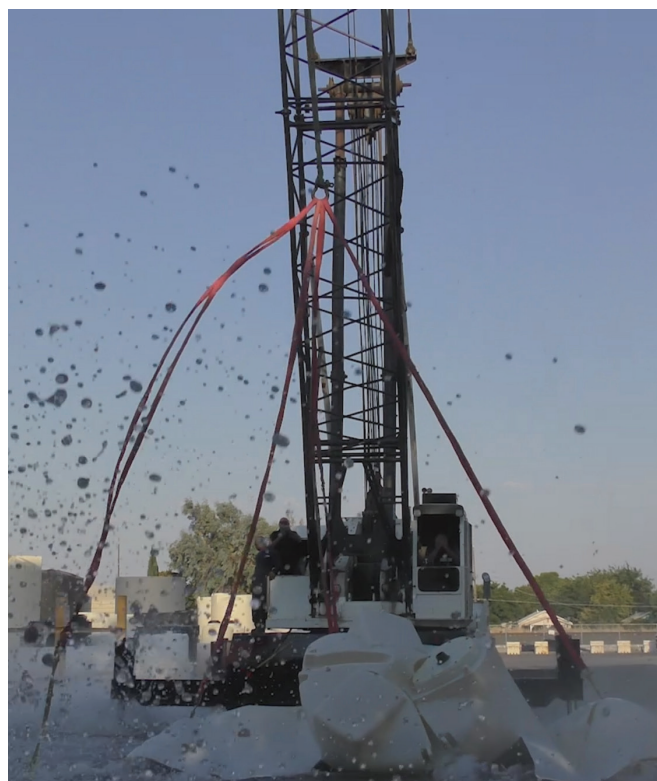
High Density Linear Polyethylene Drop Test Failure
